## Inspection Report

**Property Address:**  
1234 W. Example Dr.  
Tucson AZ 85757

**Top Tier Home Inspections L.L.C.**

<b>Date:</b> 12/29/2018	<b>Time:</b> 10:00 AM	<b>Report ID:</b> 12292018
<b>Property:</b> 1234 W. Example Dr. Tucson AZ 85757	<b>Customer:</b> Mr. Jon Smith	<b>Real Estate Professional:</b>

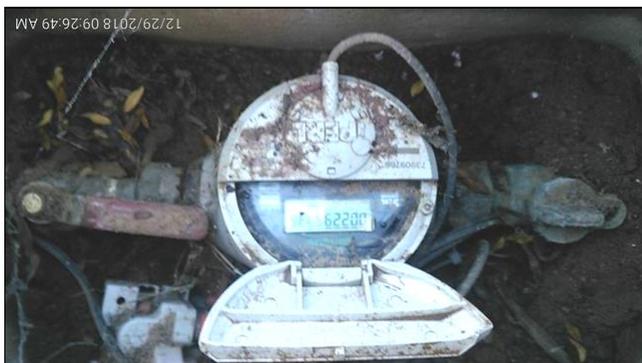
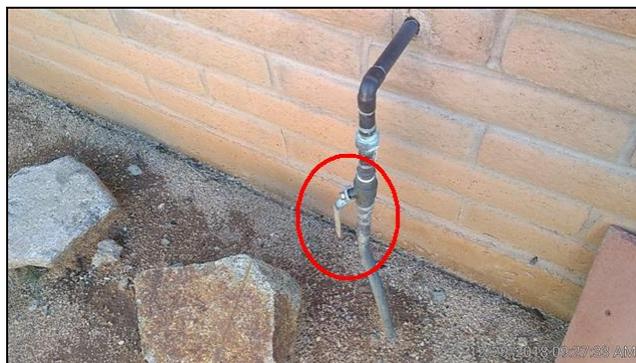
The photos show the water shut off device at the buildings exterior and the corresponding water meter. The meter was not moving at this time, indicating that there was no leak in the supply lines on the day of the inspection. While this does not absolutely guarantee that no leaks exist, it is a strong indicator and the best that can be provided during a visual home inspection.

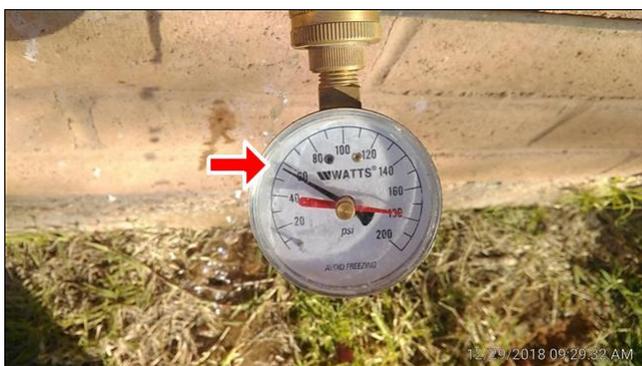
2.3 Water Pressure 58 PSI

No defects were observed for the water supply piping as identified in the Styles & Materials section. The functional flow was acceptable and the home water supply pressure was within the acceptable limits of 40 PSI and 80 PSI on the day of the inspection.

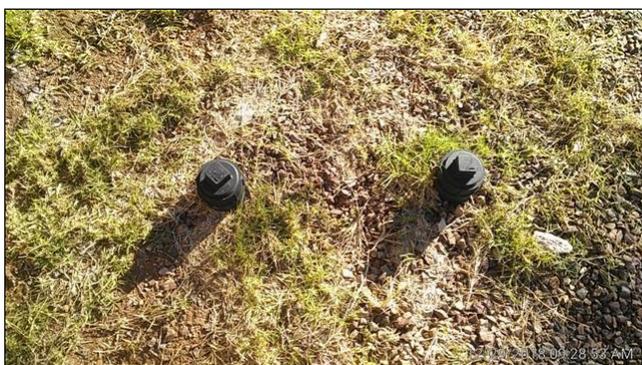
2.4 Plumbing Clean Outs

- (1) The drain / waste / vent piping as described in the Styles & Material section showed no defects on the day of the inspection. NOTE: This statement applies to the visible areas only.
- (2) The plumbing clean outs are located at the south elevation and are in acceptable condition.

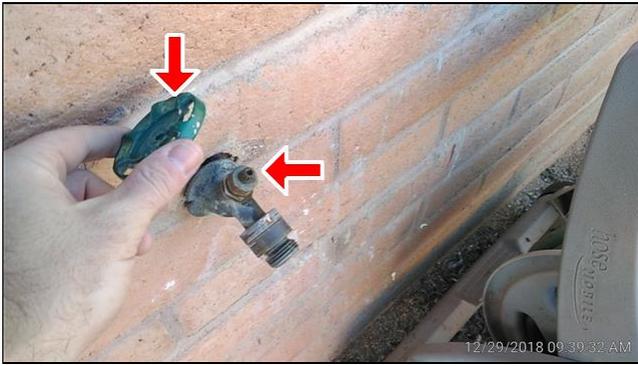
2.5

The valve for the hose bib at the north elevation is not attached to the hose bib and needs to be repaired. We recommend a qualified person review and repair as necessary.

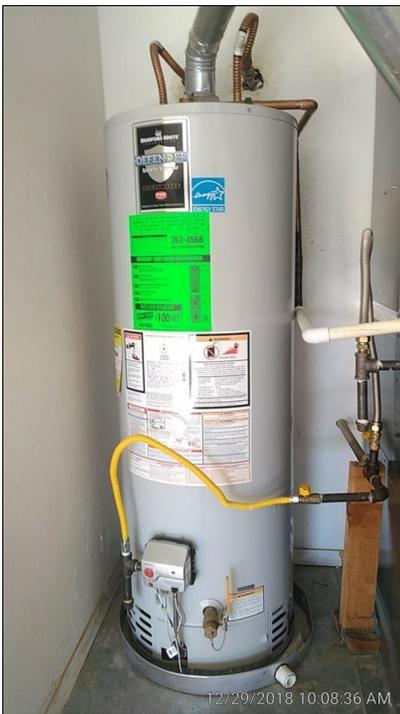
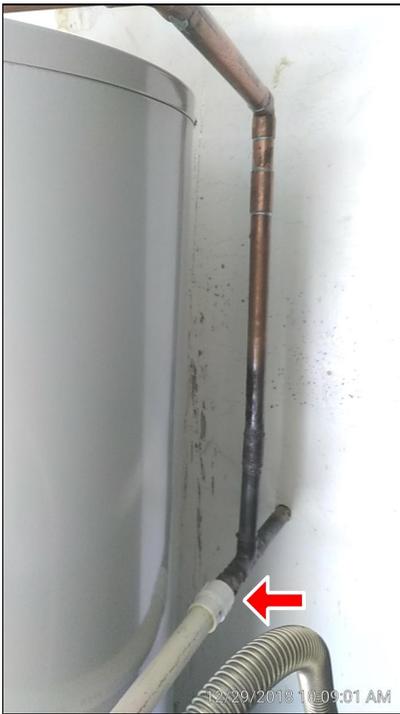
The discharge pipe for the temperature pressure relief valve is incorrectly connected to a neighboring pipe that is serving as a drainage port for the condensate drain line for the air-handler, which violates current standards. Current standards require TPR discharge pipes be piped independently of other equipment drains, water heater pans, or other relief discharge pipes to the point it safely discharges. We recommend a licensed plumber review and repair as necessary.

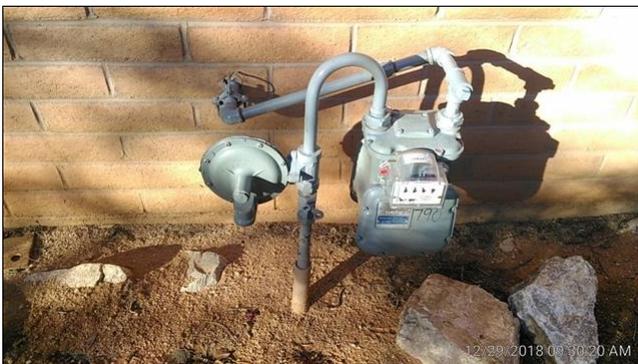
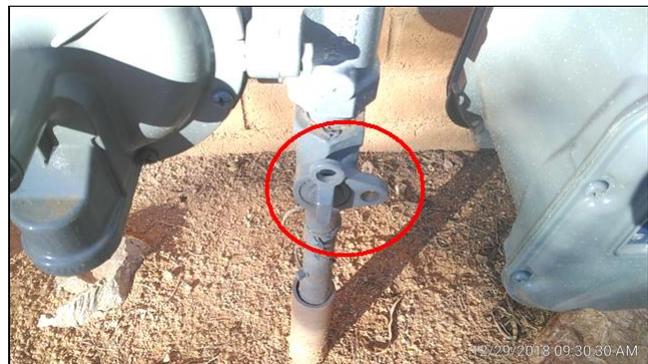
The gas shut-off valve was on and not tested, but presumed to be functional on the day of the inspection. The visible portions of the gas pipes appear to be in acceptable condition and adequately supported. Your home inspector does not test the gas pipes for leaks and can only inspect the pipes that are readily visible.

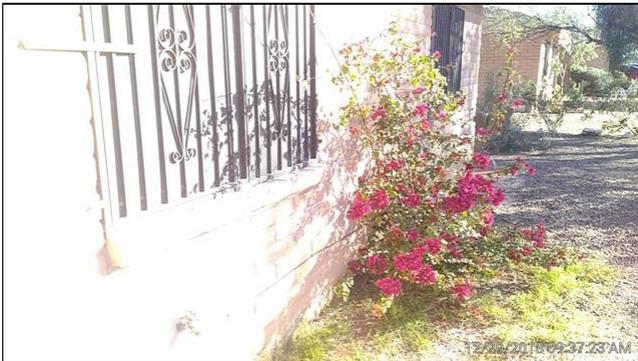
4.1

Vegetation is encroaching on the structure at the south elevation(s). This provides insects and pests easy access to the wall cladding as well as expose the wall cladding to additional moisture accelerating deterioration. We recommend keeping all vegetation a minimum of twelve inches away from the structure for the general welfare of the walls and foundation.

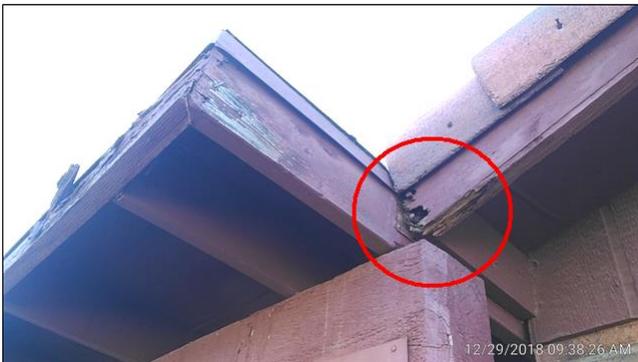
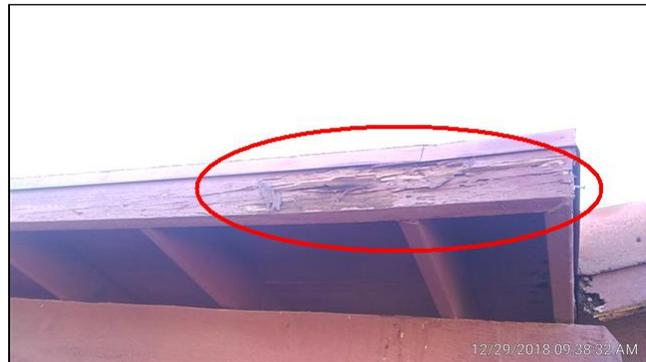
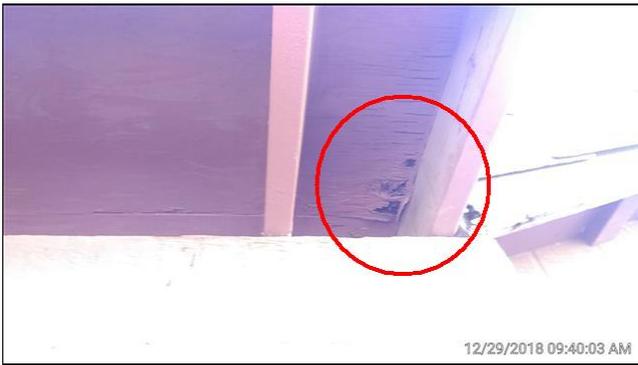
(1) Water damage and/or wood rot to the eaves, soffits, and fascias was observed at the north elevation on the back patio. NOTE: Your inspector may not have taken pictures of every damaged area. We recommend that a licensed roofing contractor review and repair as necessary.

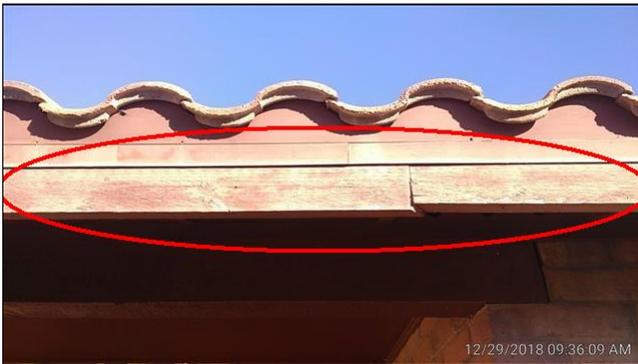
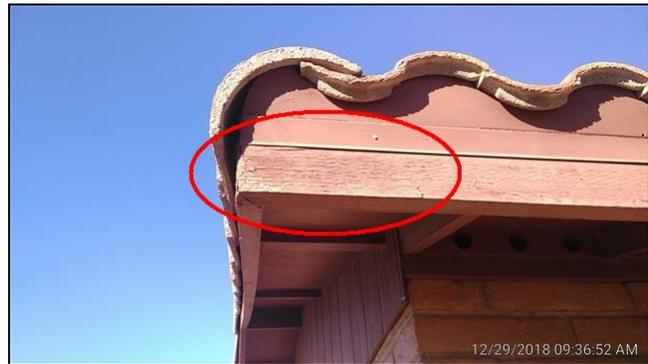
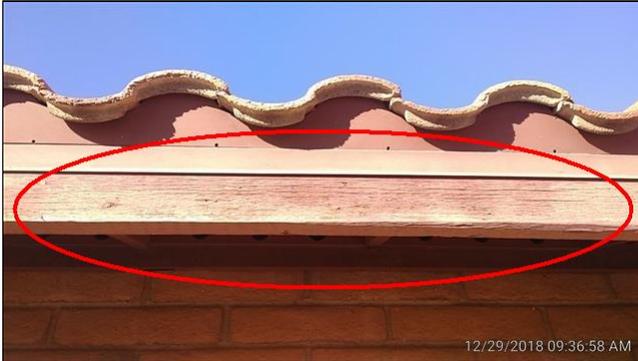
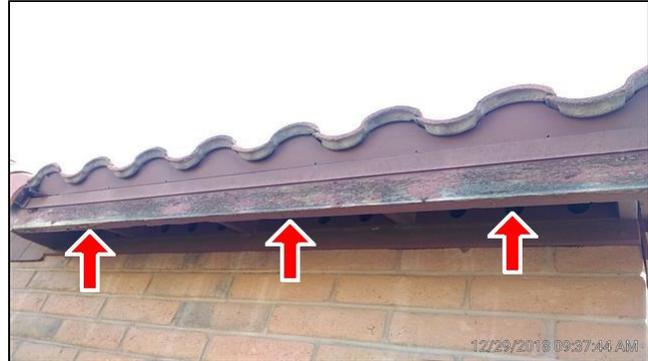
(2) The paint protecting the fascia at multiple elevation(s) is failing due to excessive heat and constant sun exposure. This leaves the wood exposed to the elements and susceptible to sun and water damage if not maintained. We recommend prep and paint by a qualified person.

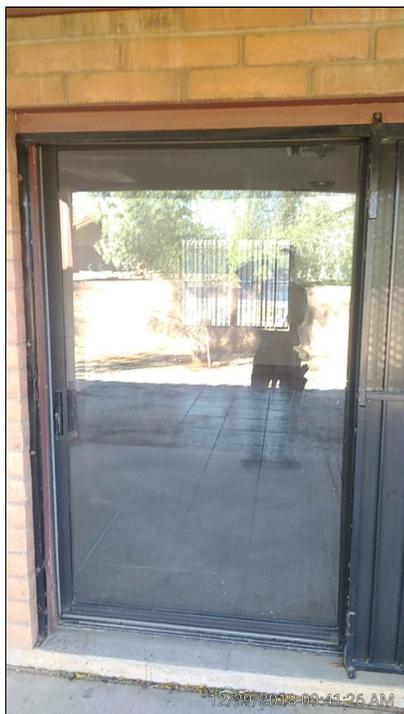
4.8

(1) The security door at the north elevation on the back patio has been removed. You may wish to have a new security gate installed for the sliding glass door leading to the backyard.

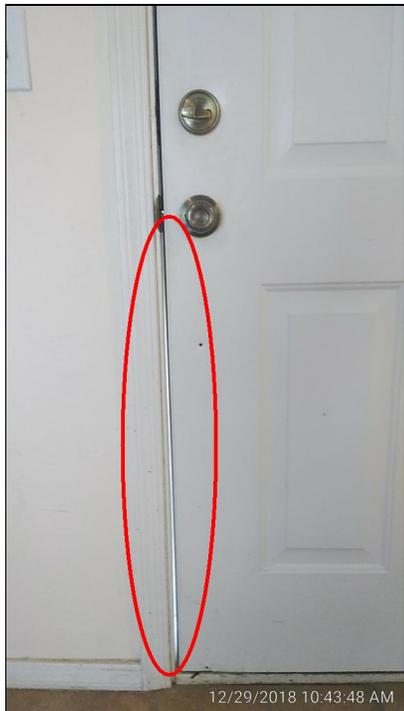
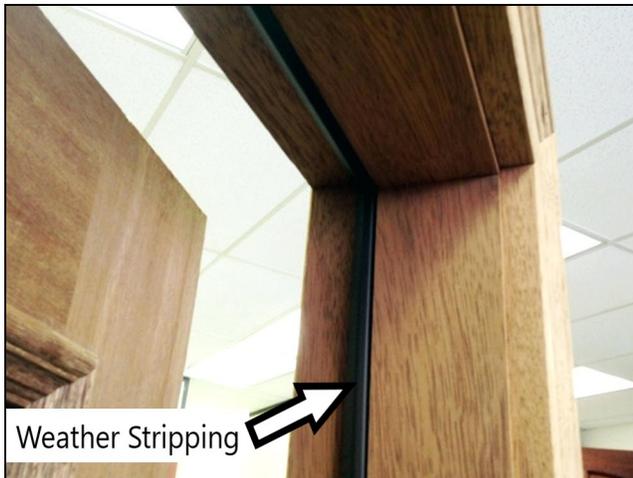
(2) The weather-stripping around the main entry door located at the south elevation(s) is deteriorated or missing which can result in water intrusion during heavy rains. We recommend replacing the weather-stripping to create a better seal around the door.

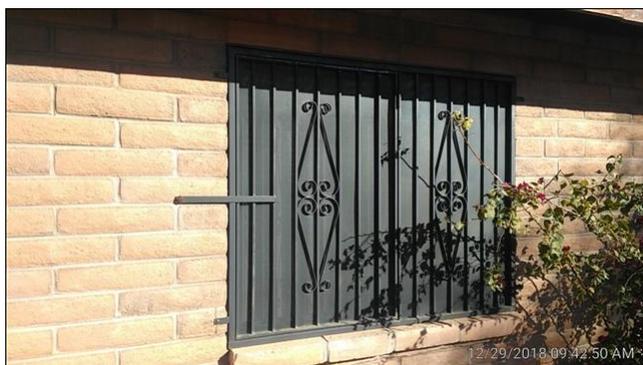
4.9

**Some or all of the windows are equipped with exterior security bars. Even with a quick-release feature, the presence of security bars may prevent or impede any attempt to enter or exit the residence during an emergency situation. We recommend having them removed from all windows.**

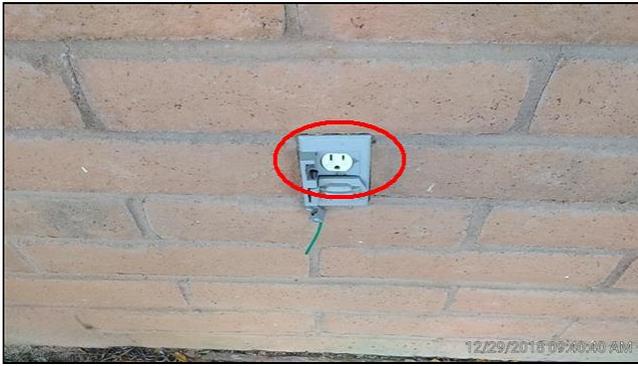
4.10

The exterior outlet(s) located at the north elevation(s) is missing the top outlet cover leaving it exposed to the elements. We recommend a qualified person install the appropriate outlet cover.

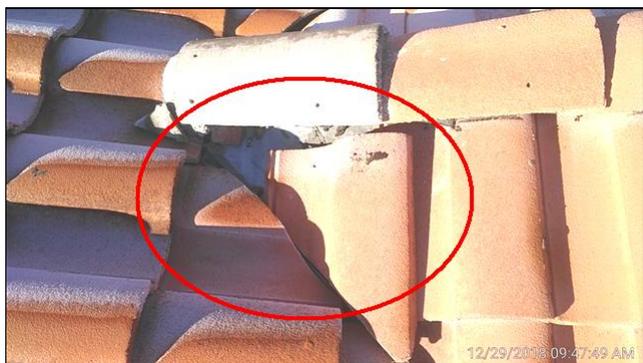
5.1

(1) Although the roof was performing its intended function on the day of the inspection, multiple roof tiles are sliding leaving the underlayment exposed. This can allow water to leak through the roof tiles and reach the underlayment below, which can cause the underlayment to deteriorate at a faster rate and eventually result in moisture intrusion and possible roof leaks. We recommend that a qualified person review and repair or replace the damaged tiles.

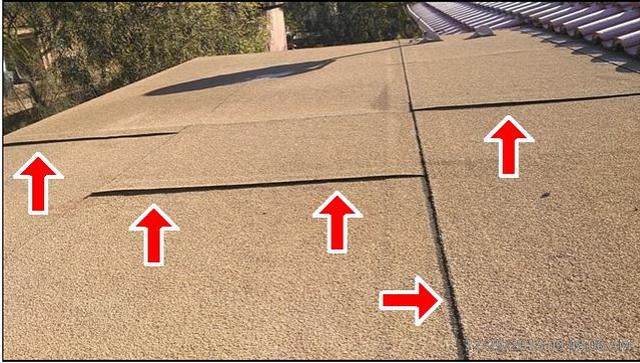
5.1

(2) The secondary roof covering is starting to curl at the seams. This will allow water to penetrate the roof covering and lead to water damage to the roof sheathing below. We recommend sealing the seams and/or applying elastomeric coating to the roof covering for additional protection.

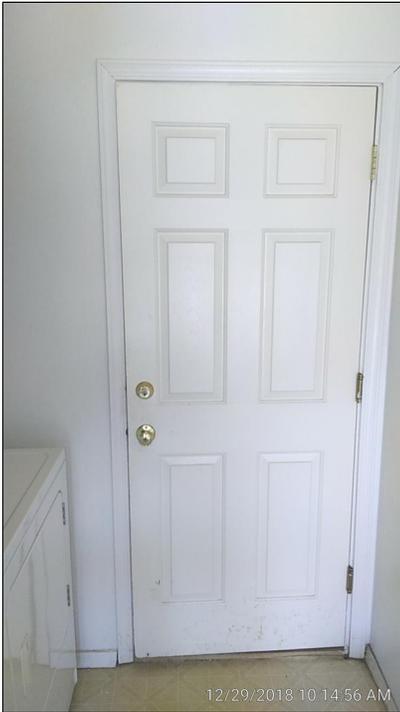
6.1

**(1) The garage entry door to the home is a self-closing door but it does not fully close and latch which compromises the firewall separation between the living space and the garage. This is a safety concern and we recommend that a qualified person review and repair or replace the self closing hinge.**

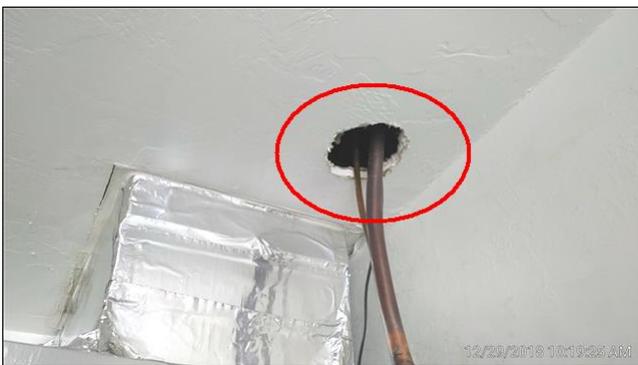
6.1

**(2) There is a hole in the ceiling of the garage which compromise the firewall separation between the garage and the living space. We recommend a qualified person patch and repair the ceiling holes in order to maintain the necessary firewall separation between the garage and the residence.**

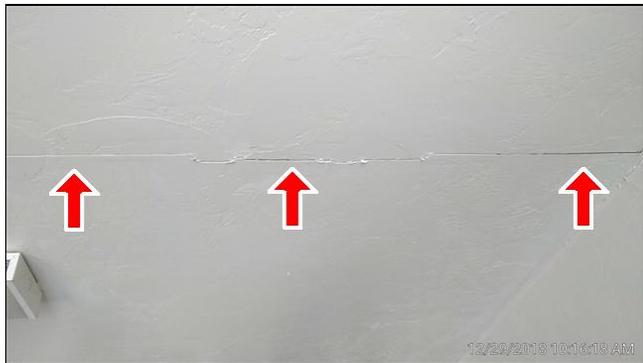
6.2

Hairline cracks were observed on the ceiling along the drywall seams. This is not a load bearing location so the cracking appears to be just a cosmetic issue and not structurally significant. We recommend a qualified person patch and repair as necessary.

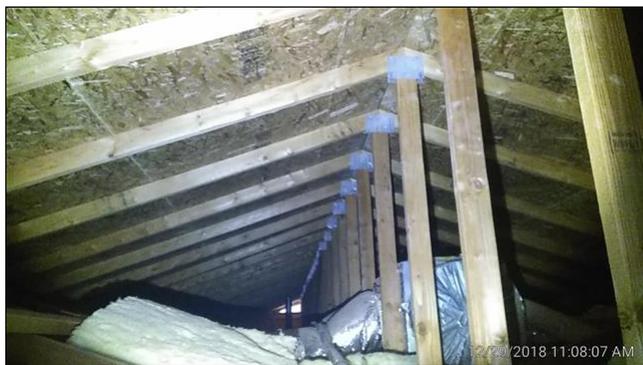
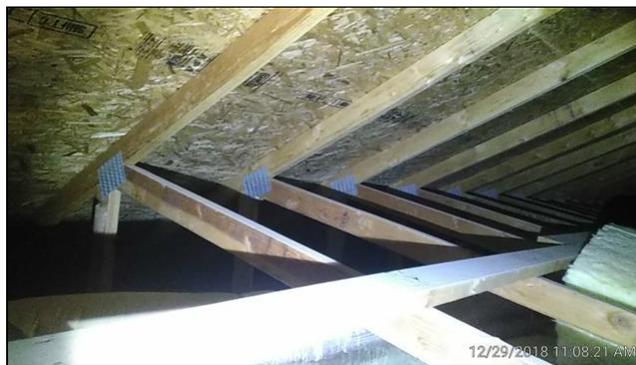
The following photos show the sections of the roof structure, within the attic, that were accessible and visible to your inspector. These areas, when visually inspected, showed no signs of any structural deficiencies on the day of the inspection.

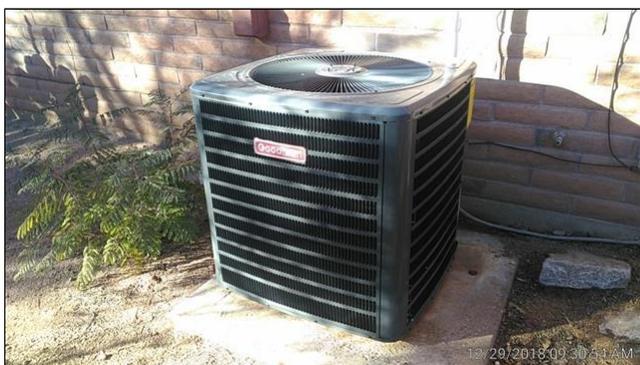
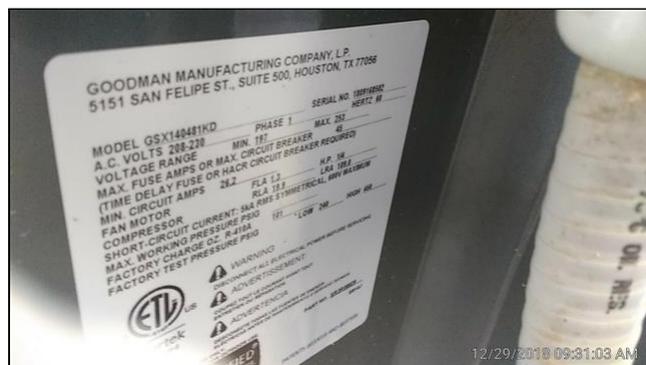
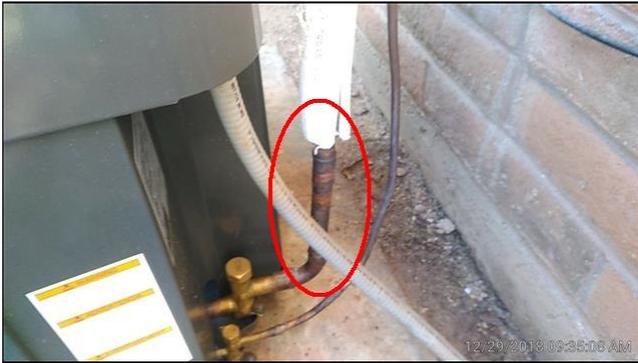
The condensing unit was not tested for proper operation due to the outside air temperature being 65 degrees or less, doing so could damage the unit and its components. Additionally, a small section of insulation is missing on the refrigerant line. We recommend insulation be installed to all exposed refrigerant lines.

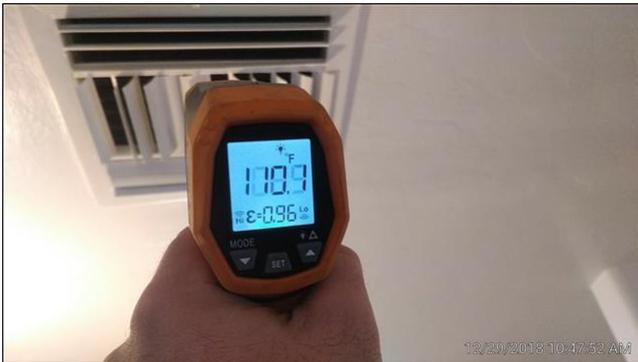
8.2 Supply Air Temperature

The furnace was functional and all components were in acceptable condition on the day of the inspection.

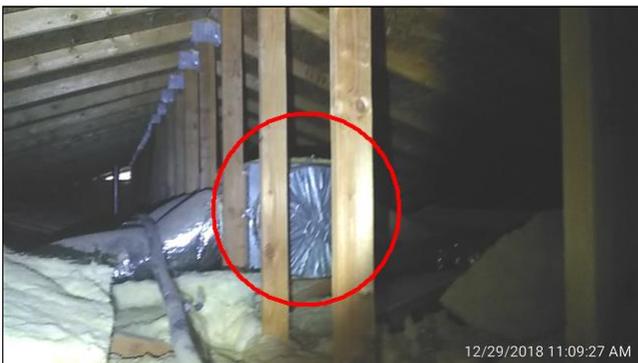
8.5

A portion of the distribution system in the attic is sealed off with duct tape. We recommend properly sealing the open distribution port.

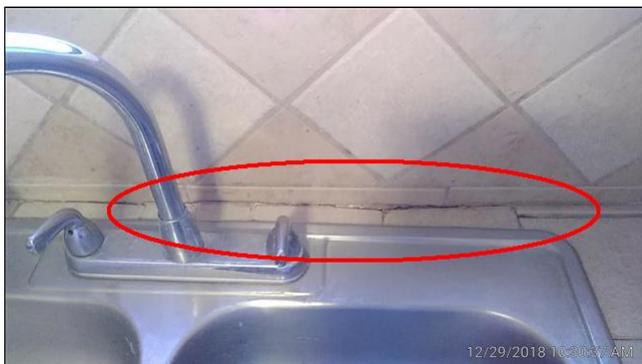
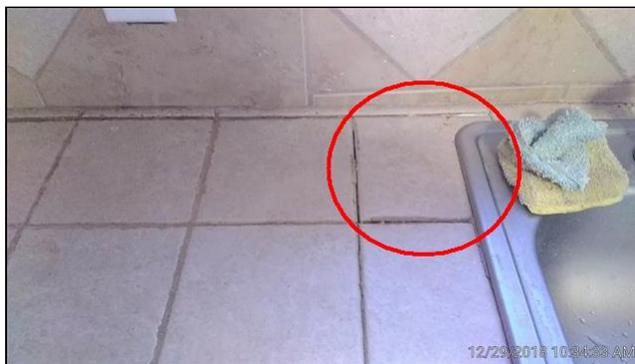
The grout and tiles behind and adjacent to the sink is cracked and damaged. This will lead to water intrusion and possible water damage as time goes on. We recommend a qualified person patch and repair as necessary.

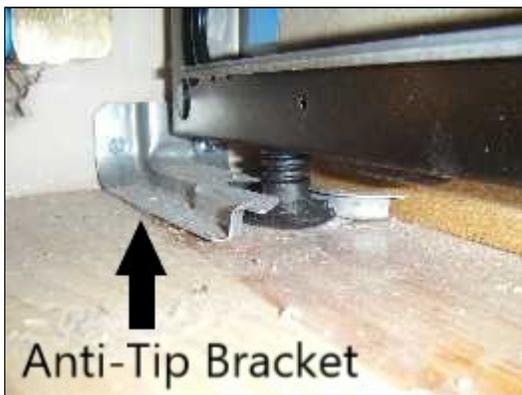
9.3 Example of Anti-Tip Bracket

The range was functional but not equipped with an anti-tip device, which prevents the range from tipping and spilling its contents, should a child stand or jump on the door of the oven if left open. This is a recommended safety feature that should be installed, and particularly if small children occupy or visit the residence.

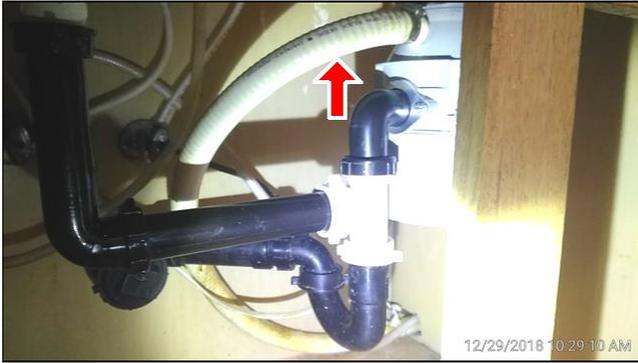
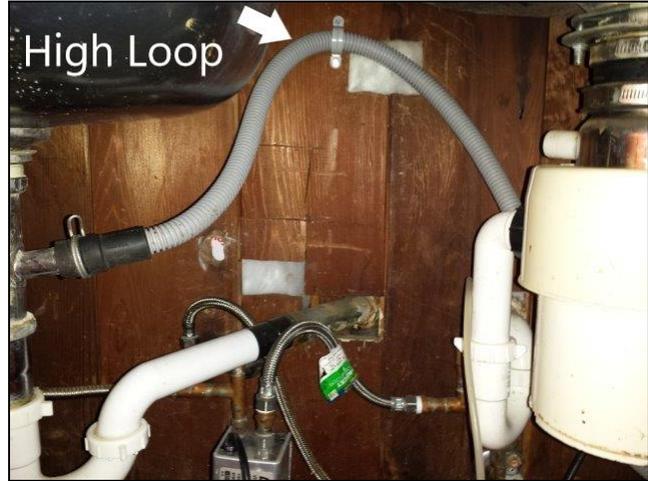
The dishwasher is functional but discharges without a mandated air gap or presence of a high loop, which prevent any contaminants in the sink from flowing into the potable water system by siphonage and is the least expensive form of backflow prevention. Additionally, the dishwasher is plugged into a GFCI outlet. This means when a GFCI outlet in the kitchen is tripped, the dishwasher will shut off. We recommend using a dedicated outlet for the dishwasher and installing a correct air gap or high loop.

9.6 No High Loop

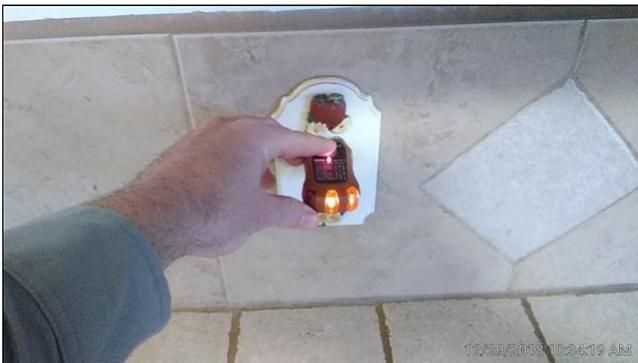
**One or more outlets in the kitchen are not GFCI protected. Although this may not have been required at the time the home was built, we recommend upgrading the kitchen outlets to meet current safety requirements.**

9.9 Not GFCI Protected

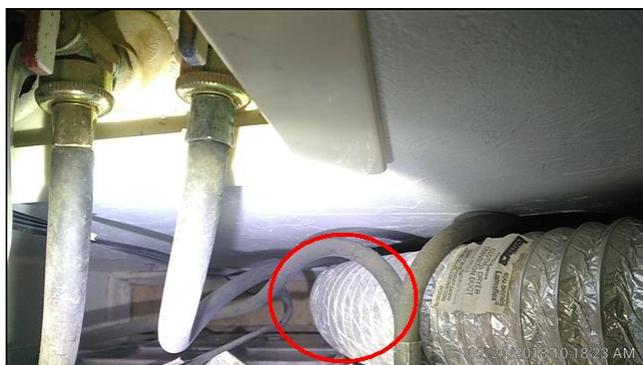
The dryer vent hose is separated from the dryer and needs to be secured in order to effectively vent any and all dryer exhaust.

10.4 Dryer Vent Separated

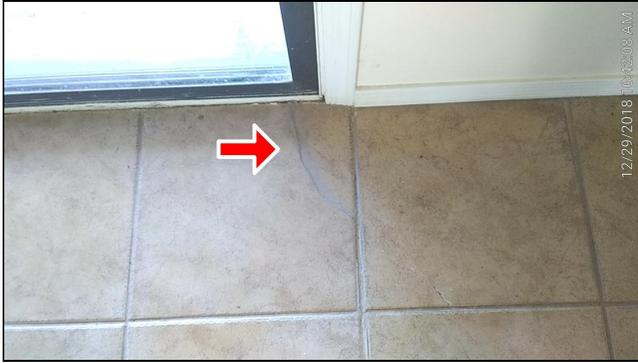
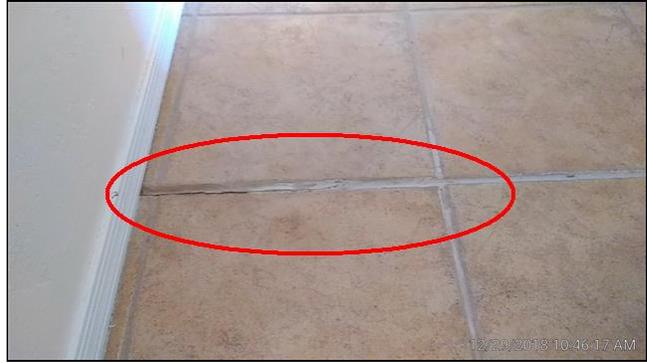
Cracked tiles were observed in living room and hallway. Although most likely caused by settling over time, you may wish to replace the cracked tiles and we recommend monitoring your flooring for additional cracked or broken tiles in the future.

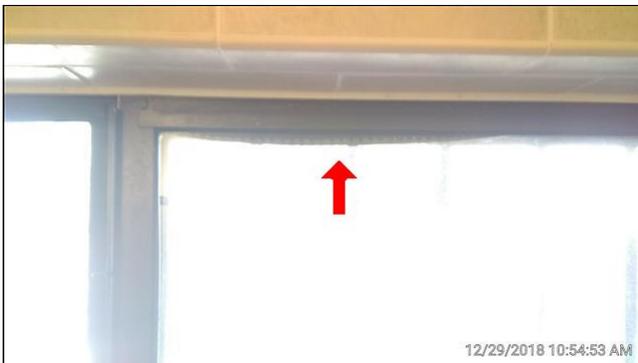
11.2

The dual pane window on the north wall in the master bathroom has migrating hermetic seals which will lead to moisture intrusion between the two window panes. This moisture intrusion will result in minor energy loss and eventually result in discoloration of the window panes. Although this is primarily a cosmetic issue, you may wish to consult with a window installation company to discuss possible repair or replacement options moving forward.

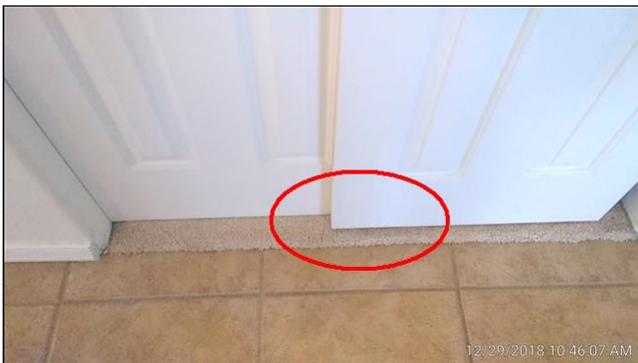
11.3

The sliding closet doors in the hallway and guest bedroom are missing the guide/track hardware which allows the closet doors to slide smoothly and prevents them from swaying forward and backward. We recommend a qualified person install the proper guide/track hardware.

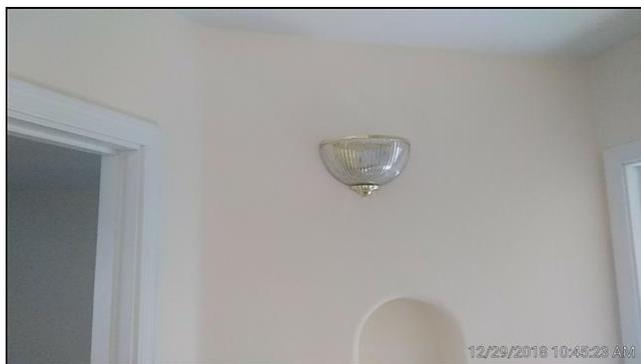
11.4

(1) The light in the hallway did not respond to a request for power. This could be due to a bad bulb or could be caused by a wiring issue. We recommend replacing the bulb and if the light still does not respond, we recommend a licensed electrician review and repair as necessary.

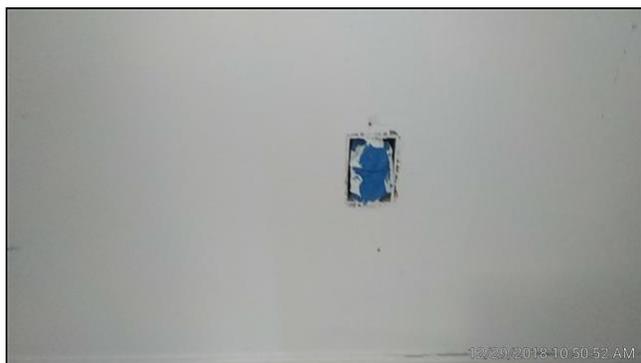
11.4

(2) An outlet in the guest bedroom closet is missing an outlet cover and one needs to be installed.

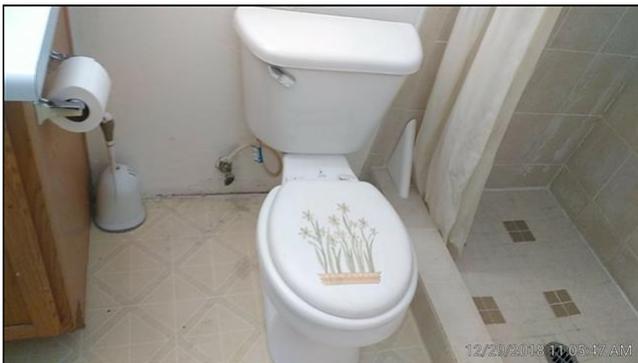
12.2

The toilet in the master bathroom runs continuously. Additionally, the toilet is loose and needs to be secured. We recommend a qualified person review and repair as necessary.

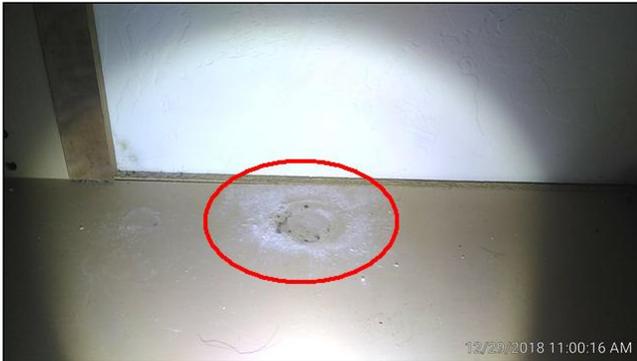
12.5

**(1) Evidence of a possible biological organism was observed in the guest bathroom below the sink. Your home inspector is not qualified to perform or conduct any tests to confirm or identify biological substances. We recommend contacting a certified mold assessor for further evaluation, testing, and recommendations.**

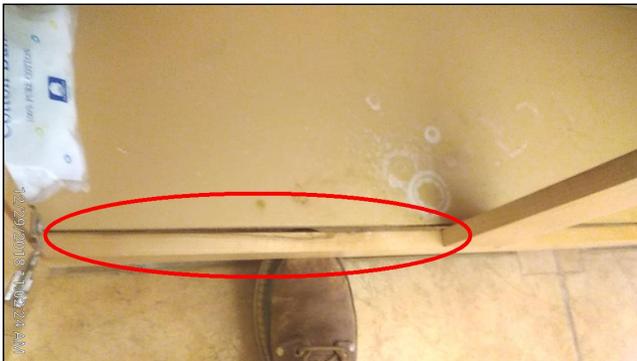
12.5

**(2) The cabinet trim is pulling away from the structure and needs to be secured.**

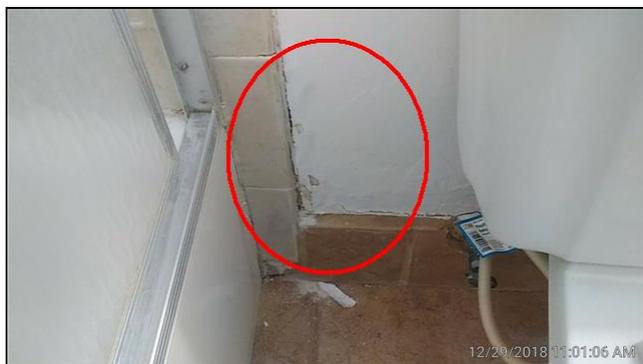
12.6

Water damage was observed on the wall directly adjacent to the bathtub or shower in the guest bathroom and the master bathroom. Although this is very common to see near showers and bathtubs, you may wish to repair or replace the damaged material.

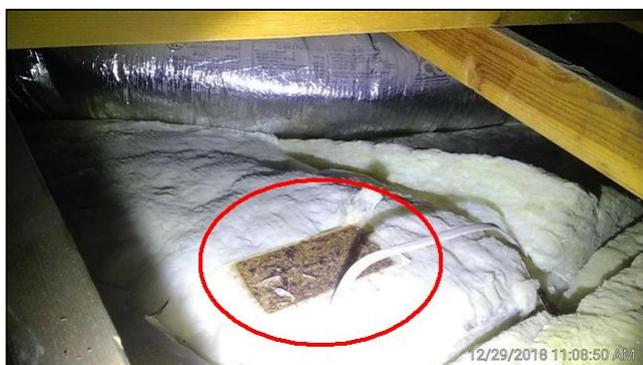
13.1

Evidence of the presence of pests or rodents was observed within the attic space. Animals living within the attic space can damage ductwork, insulation, and electrical wiring and pose a health concern to the occupants below. We recommend contacting an exterminator as soon as possible.
