Summary

Customer
Mr. Jon Smith

Address
1234 W. Example Dr.
Tucson AZ 85757

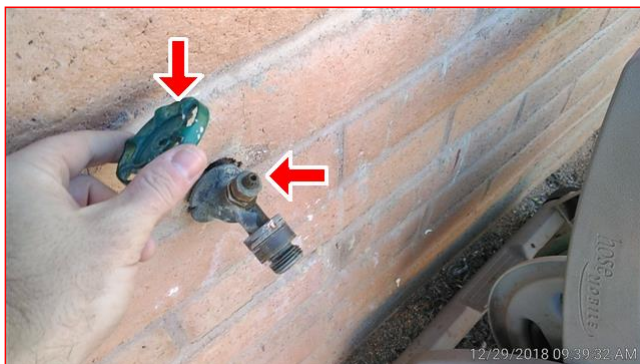
2.5

The valve for the hose bib at the north elevation is not attached to the hose bib and needs to be repaired. We recommend a qualified person review and repair as necessary.

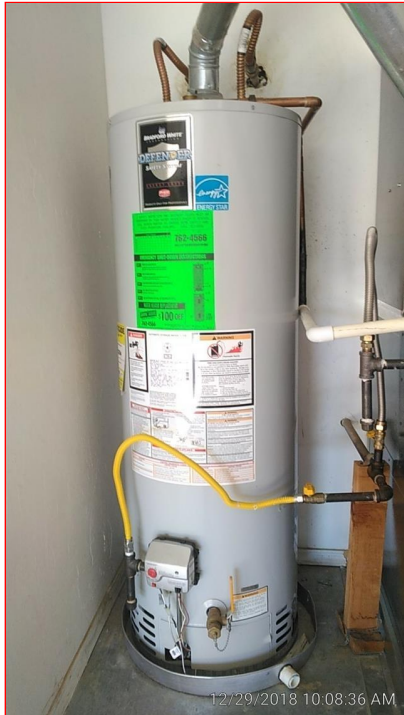
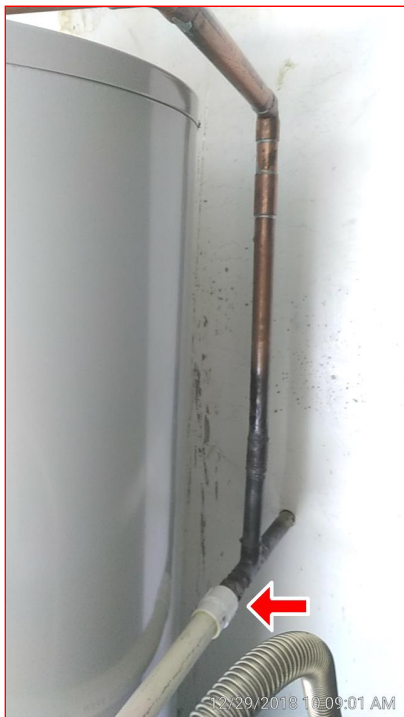
2.6

The discharge pipe for the temperature pressure relief valve is incorrectly connected to a neighboring pipe that is serving as a drainage port for the condensate drain line for the air-handler, which violates current standards. Current standards require TPR discharge pipes be piped independently of other equipment drains, water heater pans, or other relief discharge pipes to the point it safely discharges. We recommend a licensed plumber review and repair as necessary.

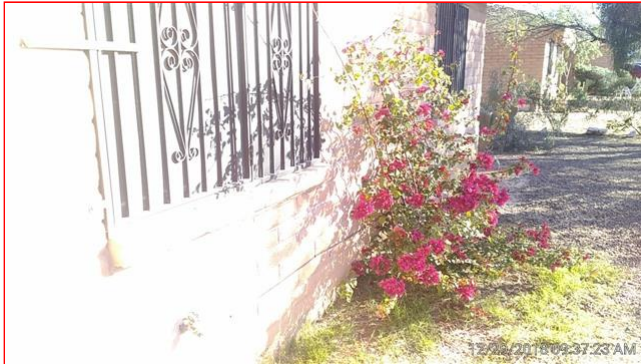
4.1

Vegetation is encroaching on the structure at the south elevation(s). This provides insects and pests easy access to the wall cladding as well as expose the wall cladding to additional moisture accelerating deterioration. We recommend keeping all vegetation a minimum of twelve inches away from the structure for the general welfare of the walls and foundation.

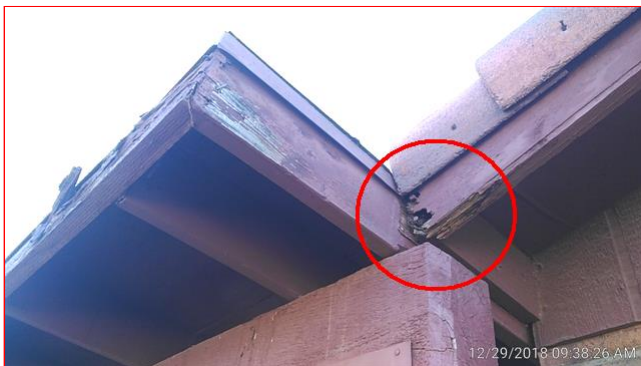
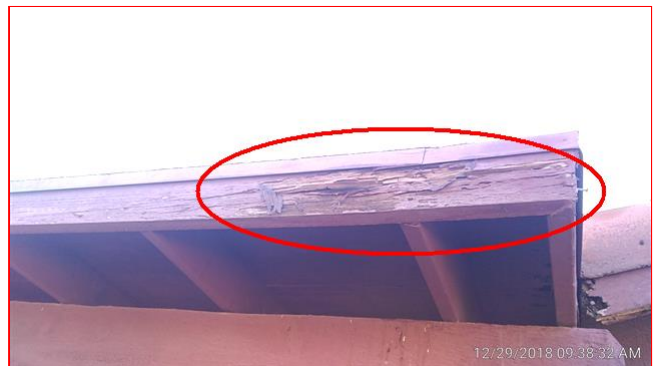
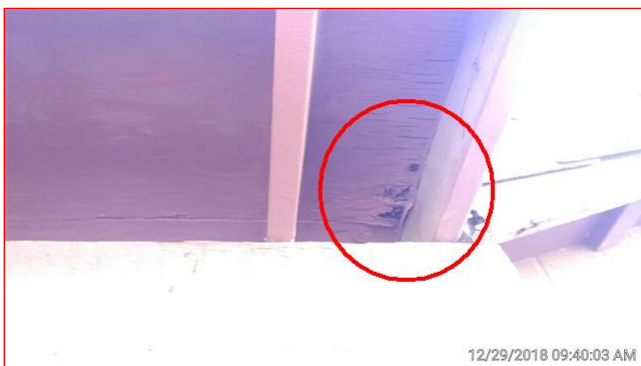
4.3

(1) Water damage and/or wood rot to the eaves, soffits, and fascias was observed at the north elevation on the back patio. NOTE: Your inspector may not have taken pictures of every damaged area. We recommend that a licensed roofing contractor review and repair as necessary.

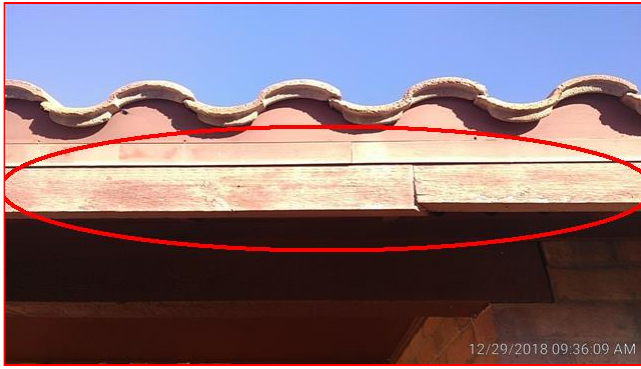
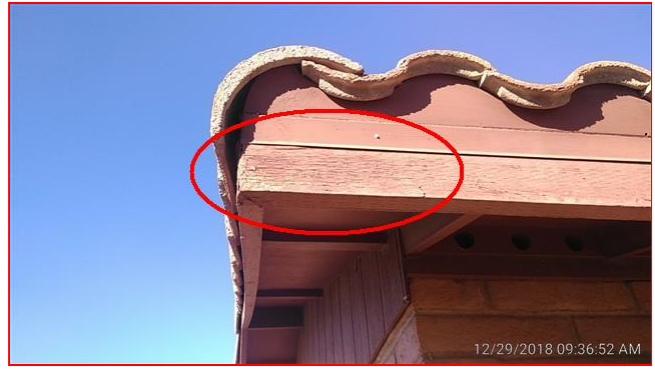
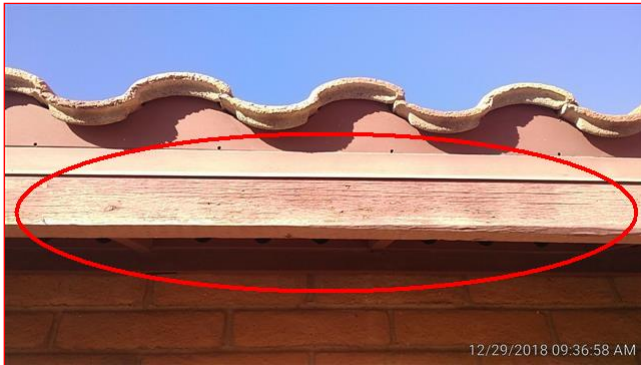
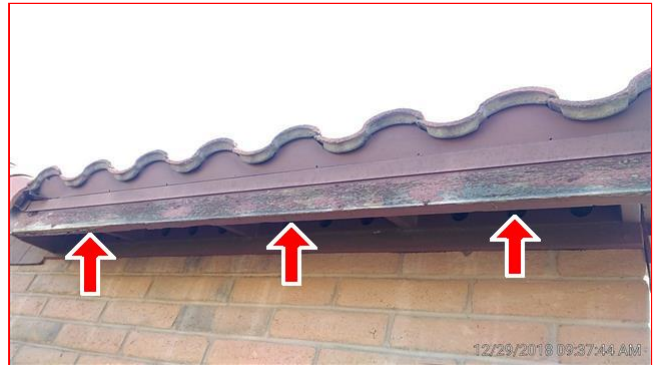
4.3 South Elevation

(2) The paint protecting the fascia at multiple elevation(s) is failing due to excessive heat and constant sun exposure. This leaves the wood exposed to the elements and susceptible to sun and water damage if not maintained. We recommend prep and paint by a qualified person.

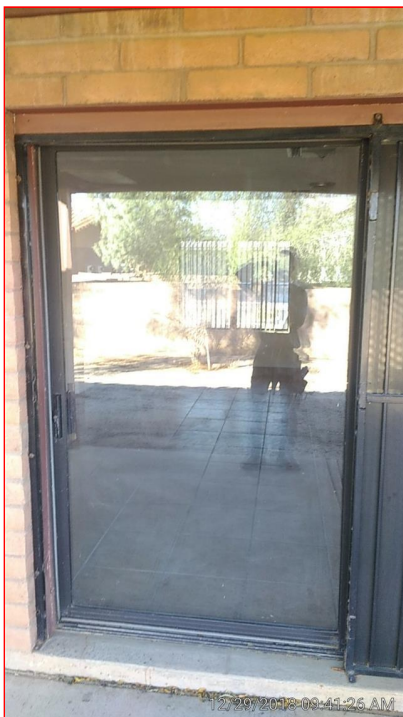
4.8

(1) The security door at the north elevation on the back patio has been removed. You may wish to have a new security gate installed for the sliding glass door leading to the backyard.

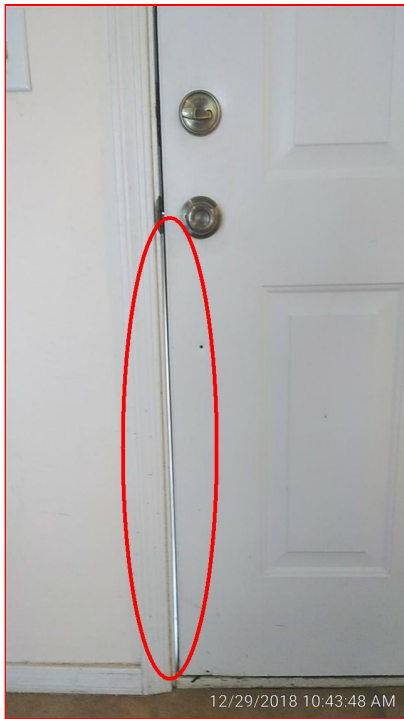
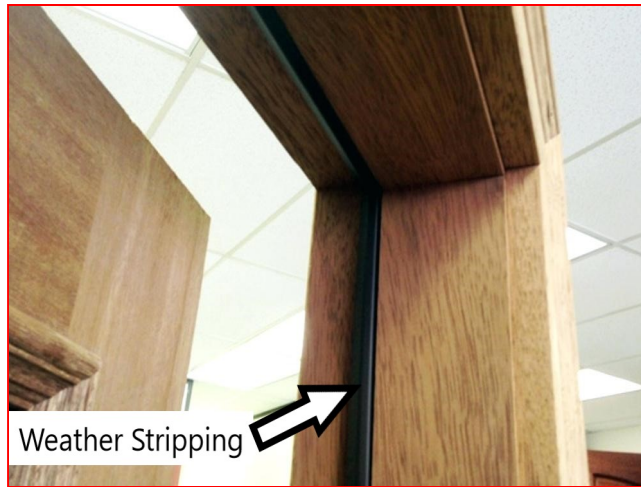
4.8 Weather Stripping

(2) The weather-stripping around the main entry door located at the south elevation(s) is deteriorated or missing which can result in water intrusion during heavy rains. We recommend replacing the weather-stripping to create a better seal around the door.

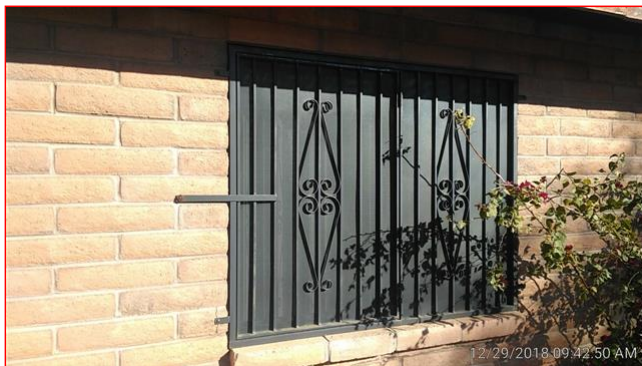
4.9

Some or all of the windows are equipped with exterior security bars. Even with a quick-release feature, the presence of security bars may prevent or impede any attempt to enter or exit the residence during an emergency situation. We recommend having them removed from all windows.

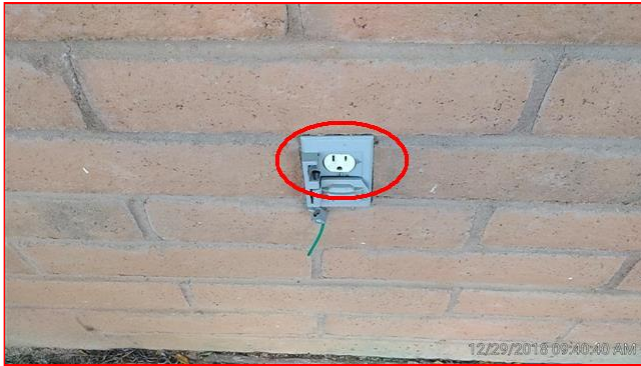
4.10

The exterior outlet(s) located at the north elevation(s) is missing the top outlet cover leaving it exposed to the elements. We recommend a qualified person install the appropriate outlet cover.

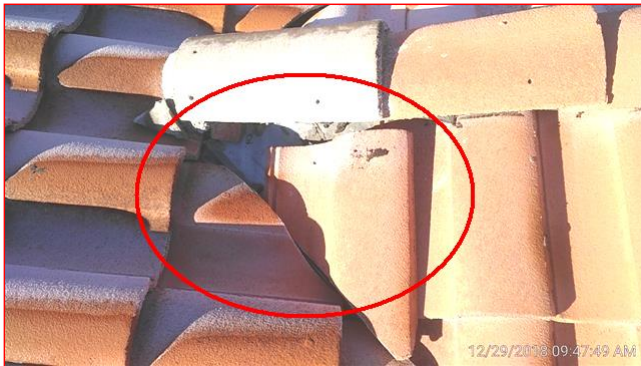
5.1

(1) Although the roof was performing its intended function on the day of the inspection, multiple roof tiles are sliding leaving the underlayment exposed. This can allow water to leak through the roof tiles and reach the underlayment below, which can cause the underlayment to deteriorate at a faster rate and eventually result in moisture intrusion and possible roof leaks. We recommend that a qualified person review and repair or replace the damaged tiles.

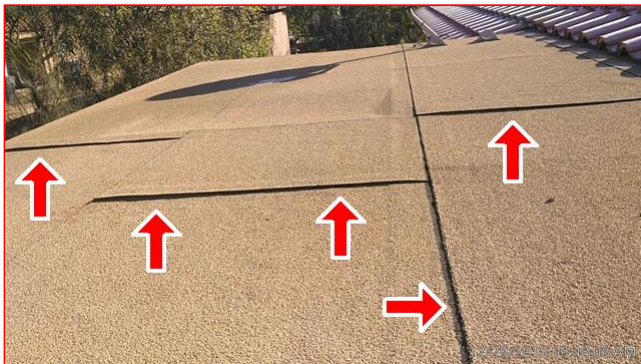
5.1

(2) The secondary roof covering is starting to curl at the seams. This will allow water to penetrate the roof covering and lead to water damage to the roof sheathing below. We recommend sealing the seams and/or applying elastomeric coating to the roof covering for additional protection.

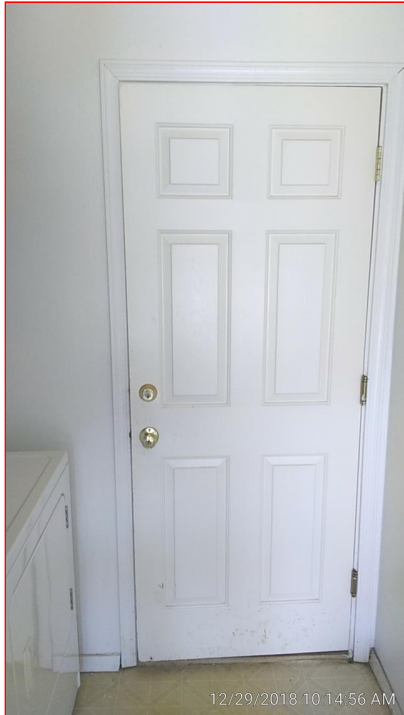
6.1

(1) The garage entry door to the home is a self-closing door but it does not fully close and latch which compromises the firewall separation between the living space and the garage. This is a safety concern and we recommend that a qualified person review and repair or replace the self closing hinge.

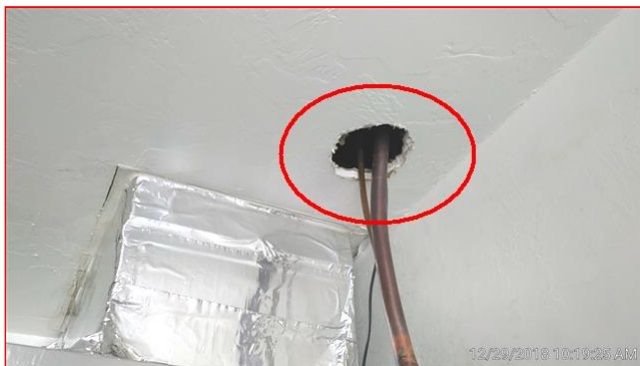
6.1

(2) There is a hole in the ceiling of the garage which compromise the firewall separation between the garage and the living space. We recommend a qualified person patch and repair the ceiling holes in order to maintain the necessary firewall separation between the garage and the residence.

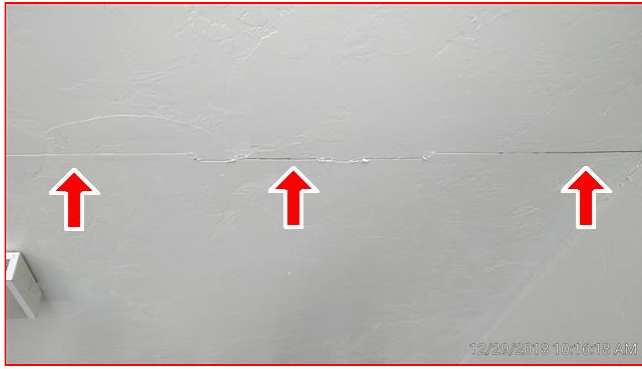
6.2

Hairline cracks were observed on the ceiling along the drywall seams. This is not a load bearing location so the cracking appears to be just a cosmetic issue and not structurally significant. We recommend a qualified person patch and repair as necessary.

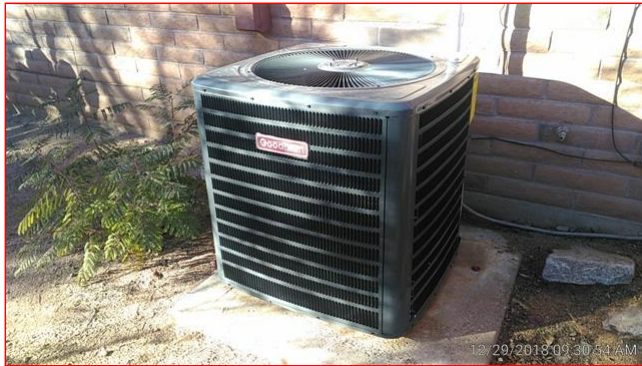
8.1 Condensing Unit

The condensing unit was not tested for proper operation due to the outside air temperature being 65 degrees or less, doing so could damage the unit and its components. Additionally, a small section of insulation is missing on the refrigerant line. We recommend insulation be installed to all exposed refrigerant lines.

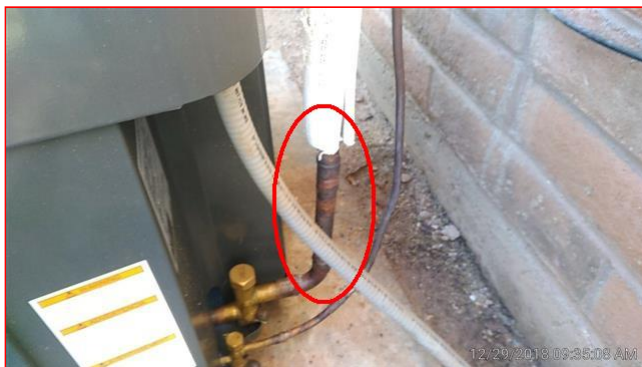
8.1 Missing Insulation

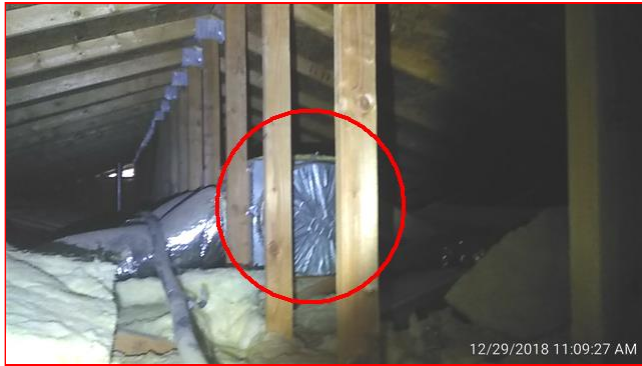
8.5

A portion of the distribution system in the attic is sealed off with duct tape. We recommend properly sealing the open distribution port.

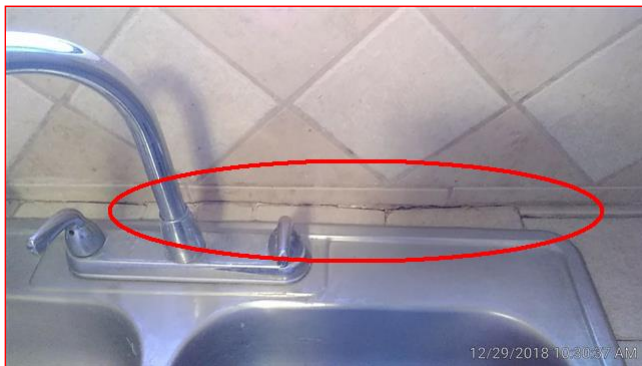
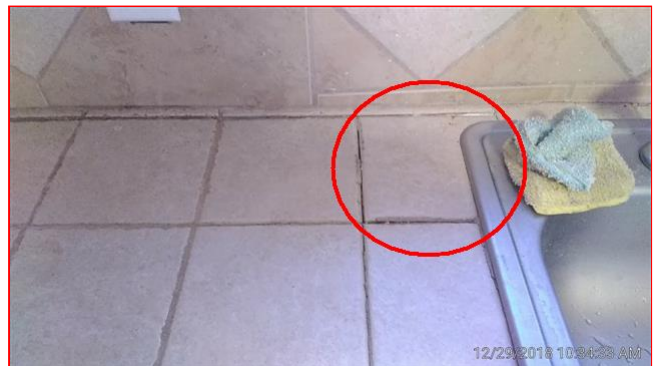
9.2

The grout and tiles behind and adjacent to the sink is cracked and damaged. This will lead to water intrusion and possible water damage as time goes on. We recommend a qualified person patch and repair as necessary.

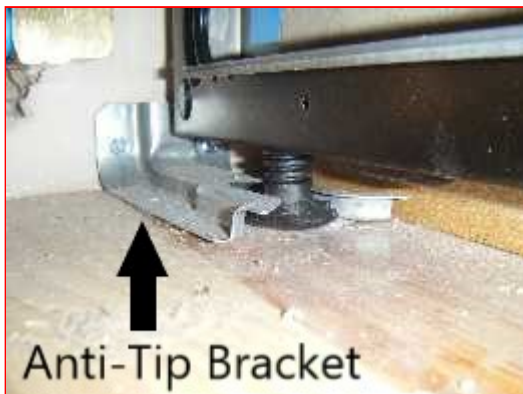
The range was functional but not equipped with an anti-tip device, which prevents the range from tipping and spilling its contents, should a child stand or jump on the door of the oven if left open. This is a recommended safety feature that should be installed, and particularly if small children occupy or visit the residence.

9.3 Example of Anti-Tip Bracket

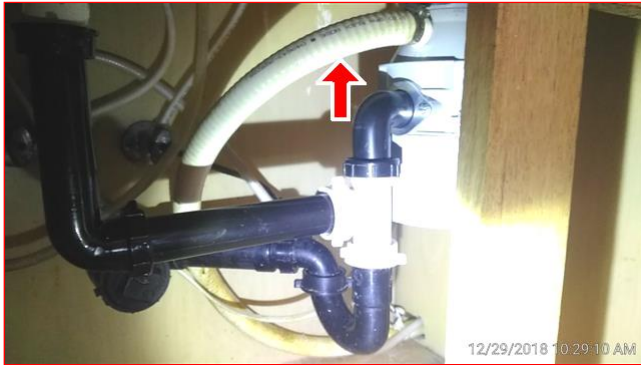
The dishwasher is functional but discharges without a mandated air gap or presence of a high loop, which prevent any contaminants in the sink from flowing into the potable water system by siphonage and is the least expensive form of backflow prevention. Additionally, the dishwasher is plugged into a GFCI outlet. This means when a GFCI outlet in the kitchen is tripped, the dishwasher will shut off. We recommend using a dedicated outlet for the dishwasher and installing a correct air gap or high loop.

9.6 No High Loop

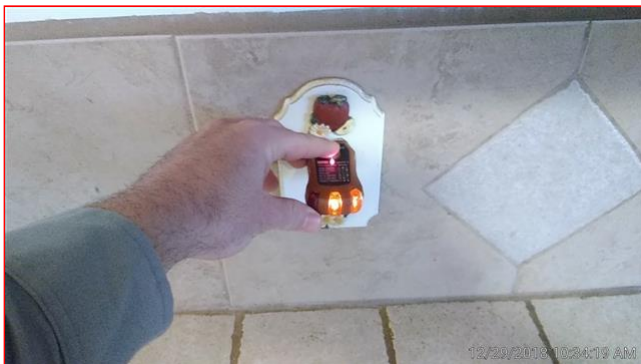
One or more outlets in the kitchen are not GFCI protected. Although this may not have been required at the time the home was built, we recommend upgrading the kitchen outlets to meet current safety requirements.

9.9 Not GFCI Protected

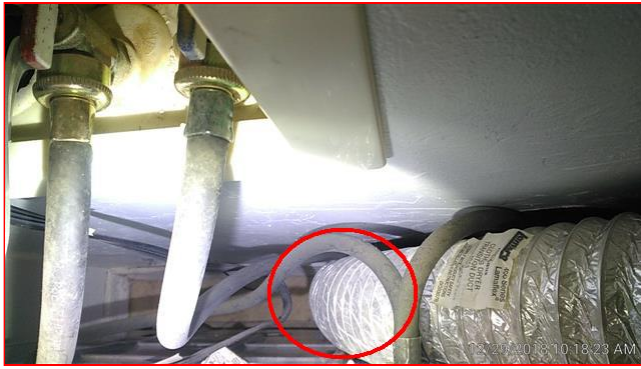
The dryer vent hose is separated from the dryer and needs to be secured in order to effectively vent any and all dryer exhaust.

10.4 Dryer Vent Separated

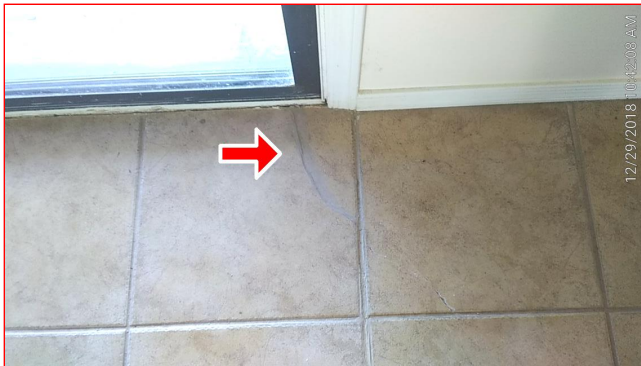
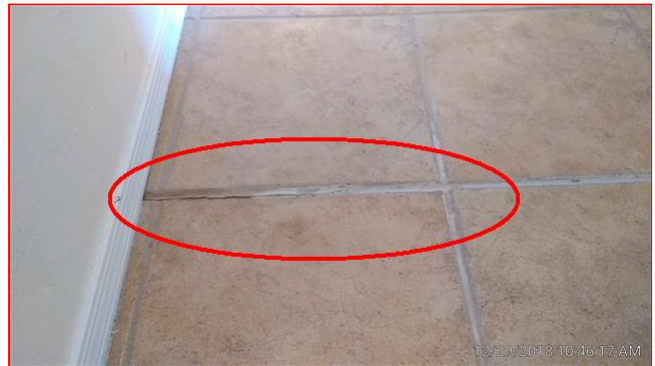
11.1

Cracked tiles were observed in living room and hallway. Although most likely caused by settling over time, you may wish to replace the cracked tiles and we recommend monitoring your flooring for additional cracked or broken tiles in the future.

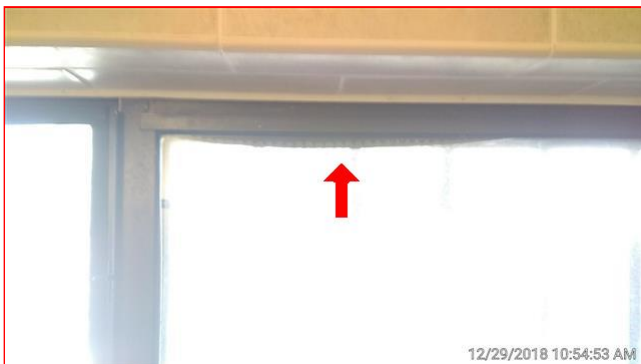
11.2

The dual pane window on the north wall in the master bathroom has migrating hermetic seals which will lead to moisture intrusion between the two window panes. This moisture intrusion will result in minor energy loss and eventually result in discoloration of the window panes. Although this is primarily a cosmetic issue, you may wish to consult with a window installation company to discuss possible repair or replacement options moving forward.

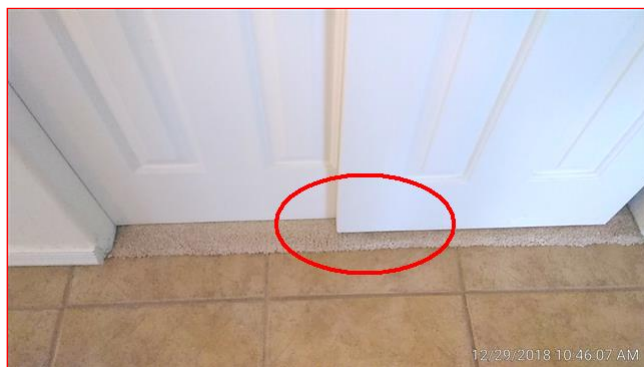
11.3

The sliding closet doors in the hallway and guest bedroom are missing the guide/track hardware which allows the closet doors to slide smoothly and prevents them from swaying forward and backward. We recommend a qualified person install the proper guide/track hardware.

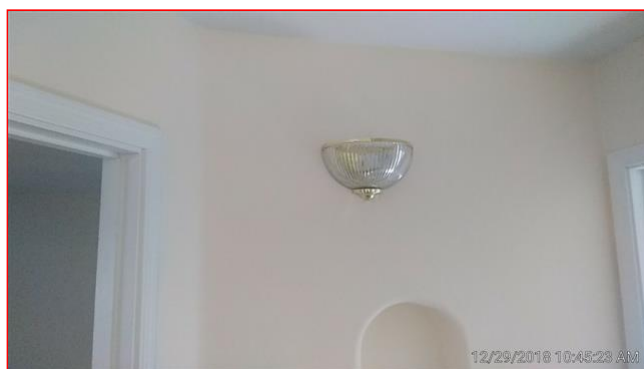
11.4

(1) The light in the hallway did not respond to a request for power. This could be due to a bad bulb or could be caused by a wiring issue. We recommend replacing the bulb and if the light still does not respond, we recommend a licensed electrician review and repair as necessary.

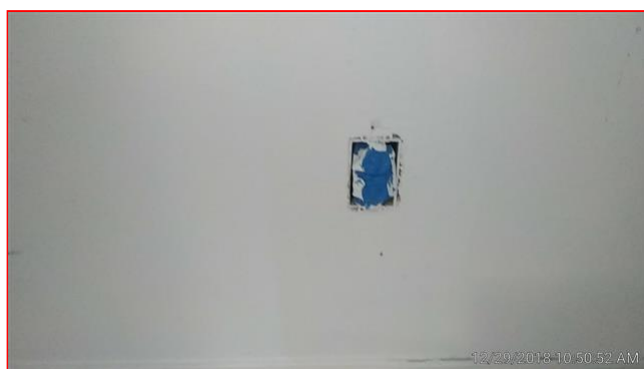
11.4

(2) An outlet in the guest bedroom closet is missing an outlet cover and one needs to be installed.

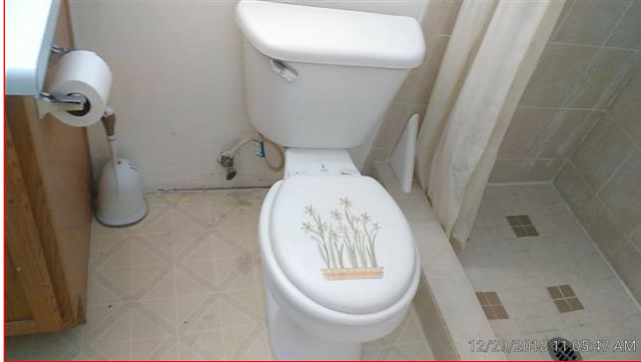
12.2

The toilet in the master bathroom runs continuously. Additionally, the toilet is loose and needs to be secured. We recommend a qualified person review and repair as necessary.

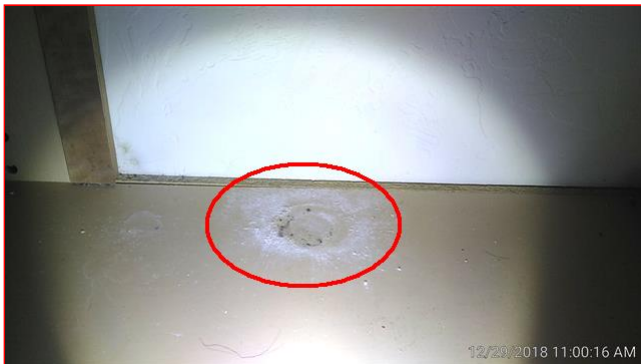
12.5

(1) Evidence of a possible biological organism was observed in the guest bathroom below the sink. Your home inspector is not qualified to perform or conduct any tests to confirm or identify biological substances. We recommend contacting a certified mold assessor for further evaluation, testing, and recommendations.

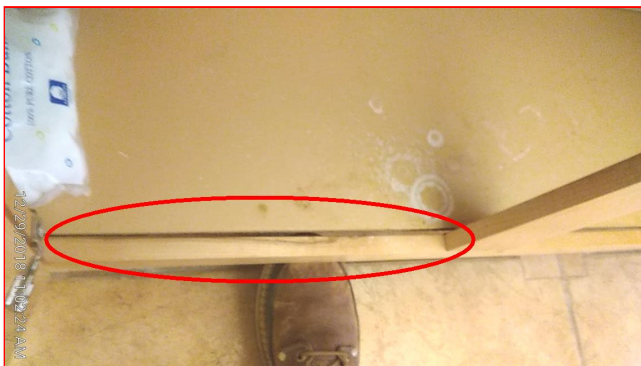
12.5

(2) The cabinet trim is pulling away from the structure and needs to be secured.

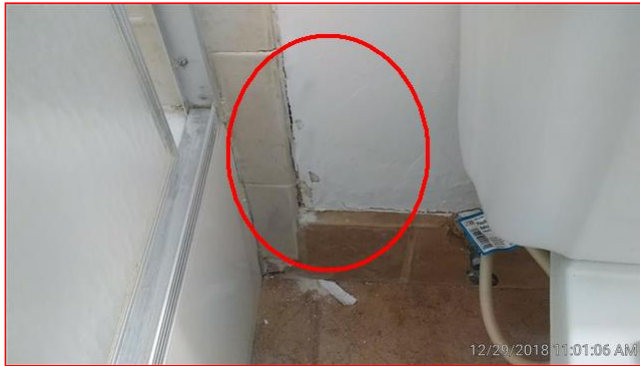
12.6

Water damage was observed on the wall directly adjacent to the bathtub or shower in the guest bathroom and the master bathroom. Although this is very common to see near showers and bathtubs, you may wish to repair or replace the damaged material.

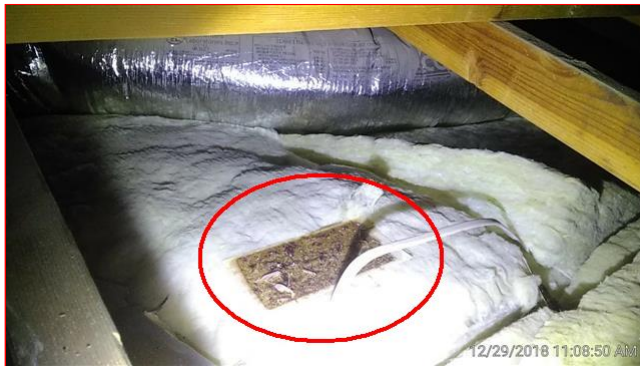
13.1

Evidence of the presence of pests or rodents was observed within the attic space. Animals living within the attic space can damage ductwork, insulation, and electrical wiring and pose a health concern to the occupants below. We recommend contacting an exterminator as soon as possible.
